Opti S Invisible floating bottom stop

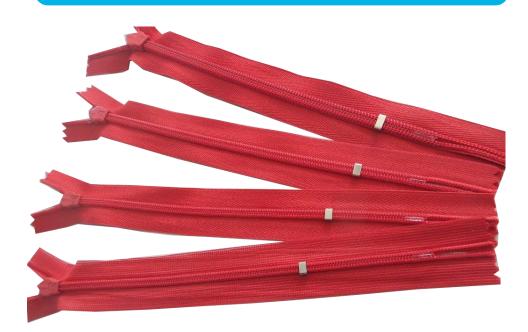
Opti S Invisible floating bottom stop is made to protect the seam, fabric or lining from being damaged by the slider.

The additional floating bottom stop can be moved along the zip length and positioned as necessary, depending on the required effective opening length. When adjusted to just above the seam bartack it prevents:
